**Shandong Chambroad Timber Material Co. Ltd**

## ***Product info***

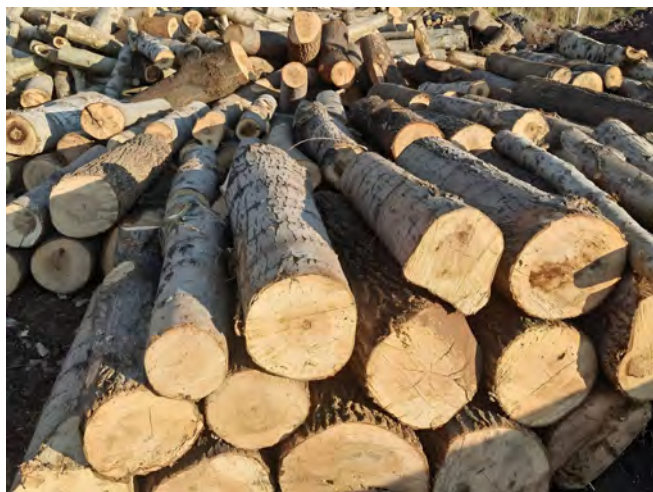
**Poplar trunk**

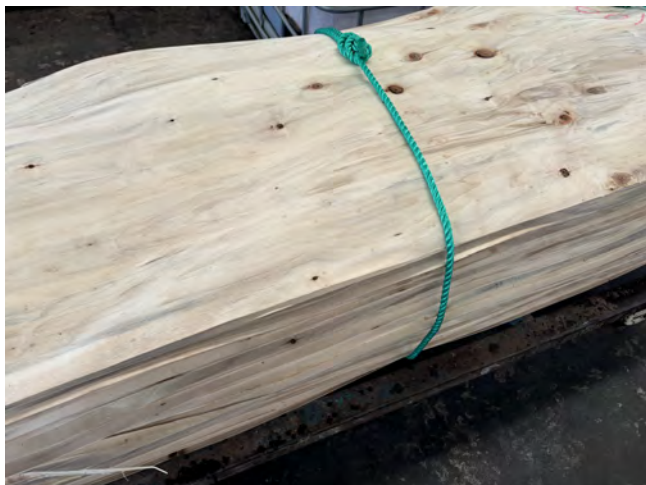
**Rotary-cut to veneer**

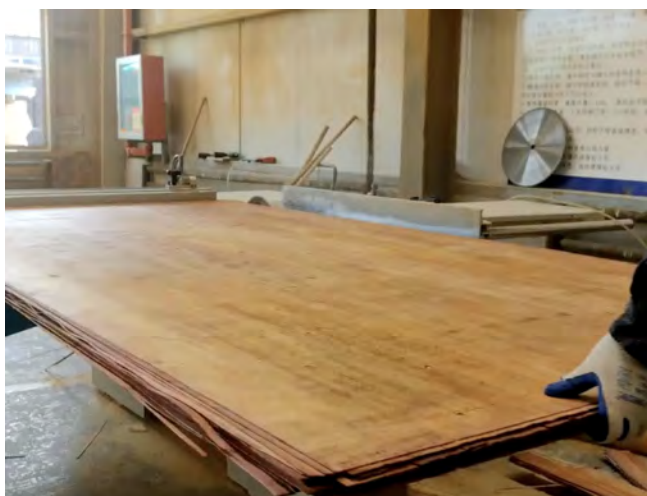
**Press to sheet**

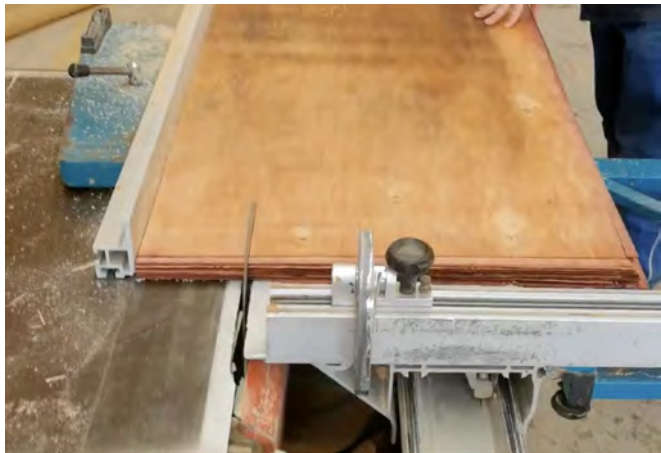
**Cut to size**

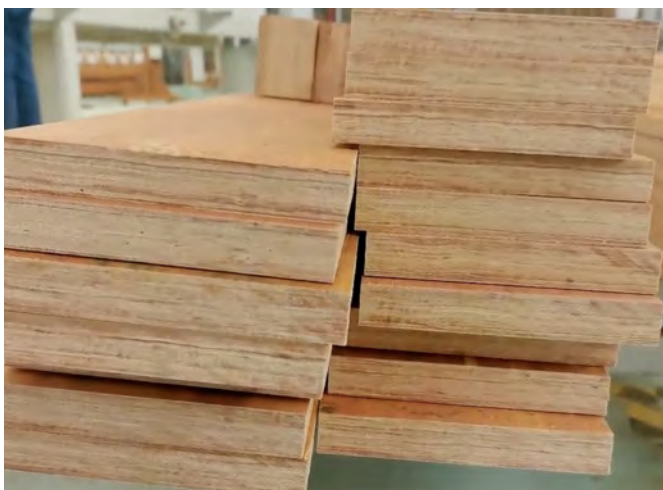
**Rough-plane**

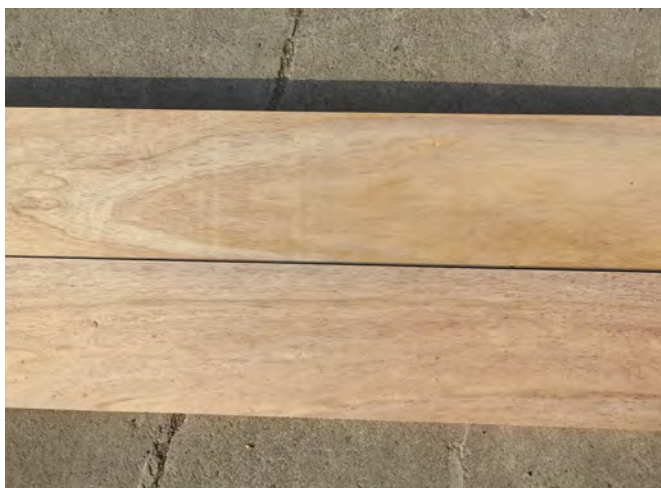
**Sanded**

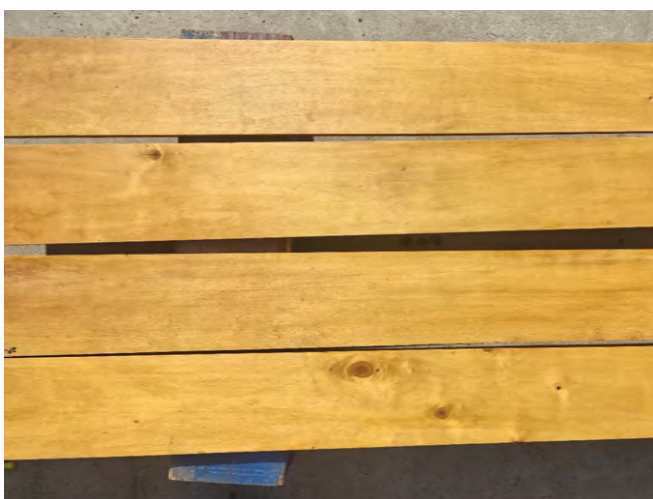
**Oiled**

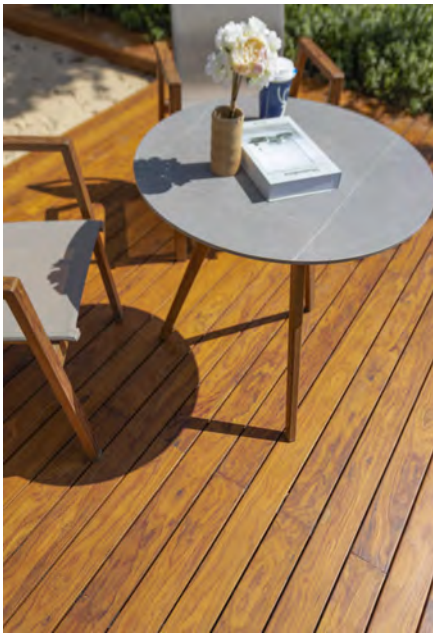
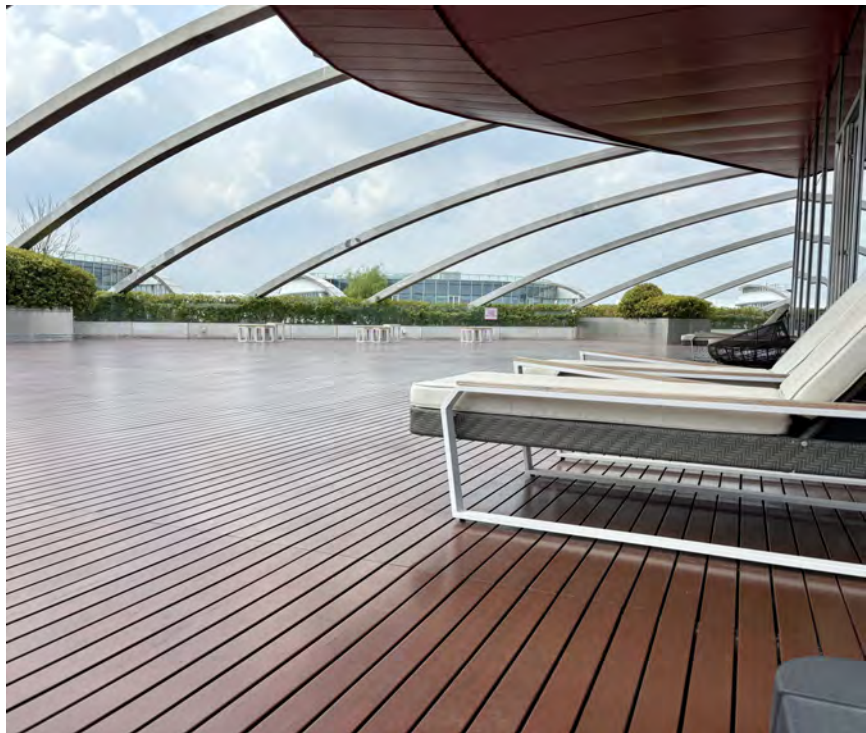
# Painted decking after 1-2 years

No change of paint and boards.

Mass lost 0.95mm.  
Fading of paint, no change of boards, stable performance.

Bending strength 139.5MPa, mass lost 1.31mm.  
Wrinkling of paints, slight chapping of boards, no other visible changes.

Bending strength 139.5 Mpa, mass lost 1,51mm.  
Faded paint, and colour fade to grey, slight chapping.  
No sign of cracking, warping, delamination etc.

Maintenance of cleaning, rinsing, polishing, oiling revived the decking as new.

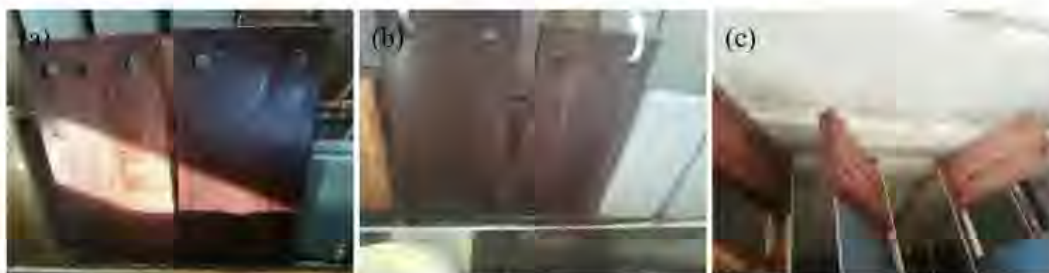
Figure 1 Salt spray test of 504 hours

Figures 1-3 below show the neutral salt spray test of three different samples for 504 hours, 1200 hours, and 1682 hours, respectively. The samples in each figure are teak, merbau and Chambroad Timber from left to right. After 504 hours of neutral salt spray test, as shown in Figure 1, there was no significant change in the surface properties of the three samples, and no obvious corrosion products were found. **After 1200 hours of neutral salt spray test, as shown in Figure 2, there was no significant change in the surface physical properties of the three samples, and no obvious corrosion products were found, but compared with Chambroad Timber, teak and merbau's surfaces had obvious salt residues.** After 1682 hours of neutral salt spray test, as shown in Figure 3, there was still no significant change in the surface properties of the three antiseptic woods, and no obvious corrosion products were found, but it can be seen that the adsorption capacity of merbau, teak, and Chambroad Timber decreased in turn. Since there was no obvious change on the material surface after 1680 hours of neutral salt spray test, the salt spray time was extended. **After 2560 hours of salt spray test, as shown in Figure 4, after the salt spray test, the shapes of the three types of wood did not change significantly, and there was no cracking or surface peeling.** However, the surface color of the materials deepened to varying degrees, among which teak had the most serious deepening, followed by malachite, and Chambroad Timber had the lightest deepening.

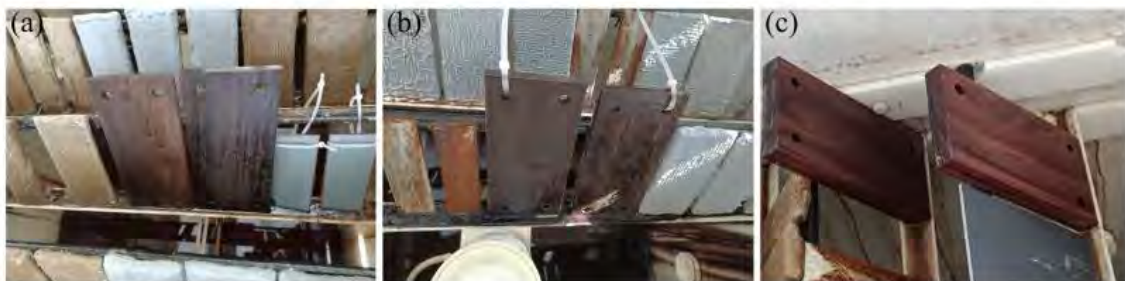
Figure 2 Salt spray test of 1200 hours

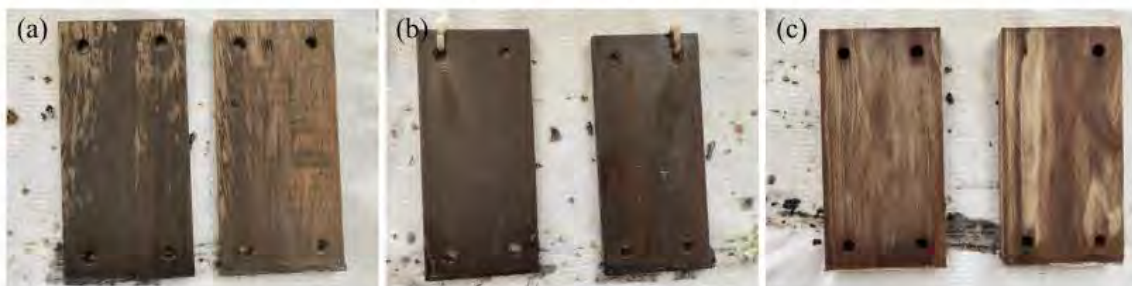
Figure 3 Salt spray test of 1200 hours

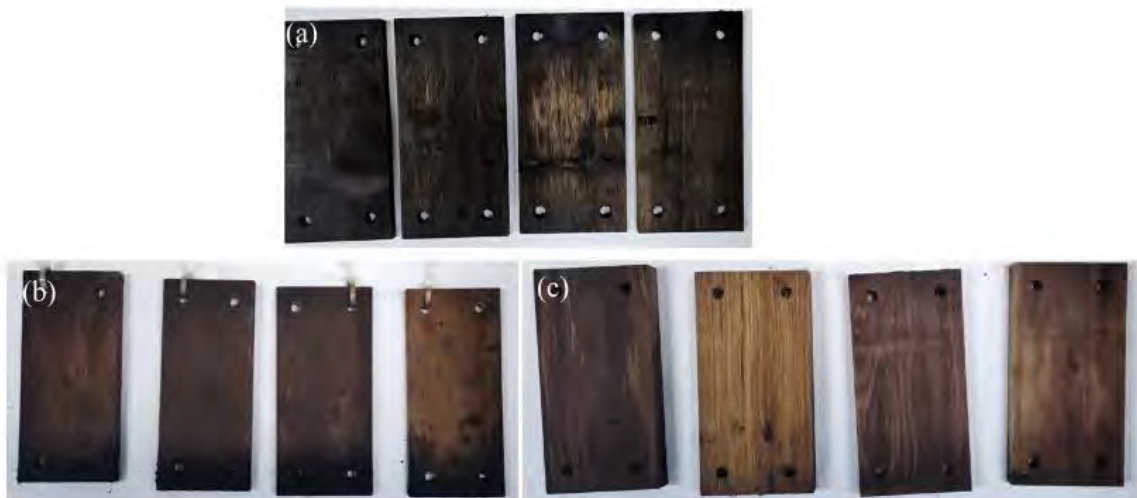
Figure 4 Salt spray test of 2560 hours

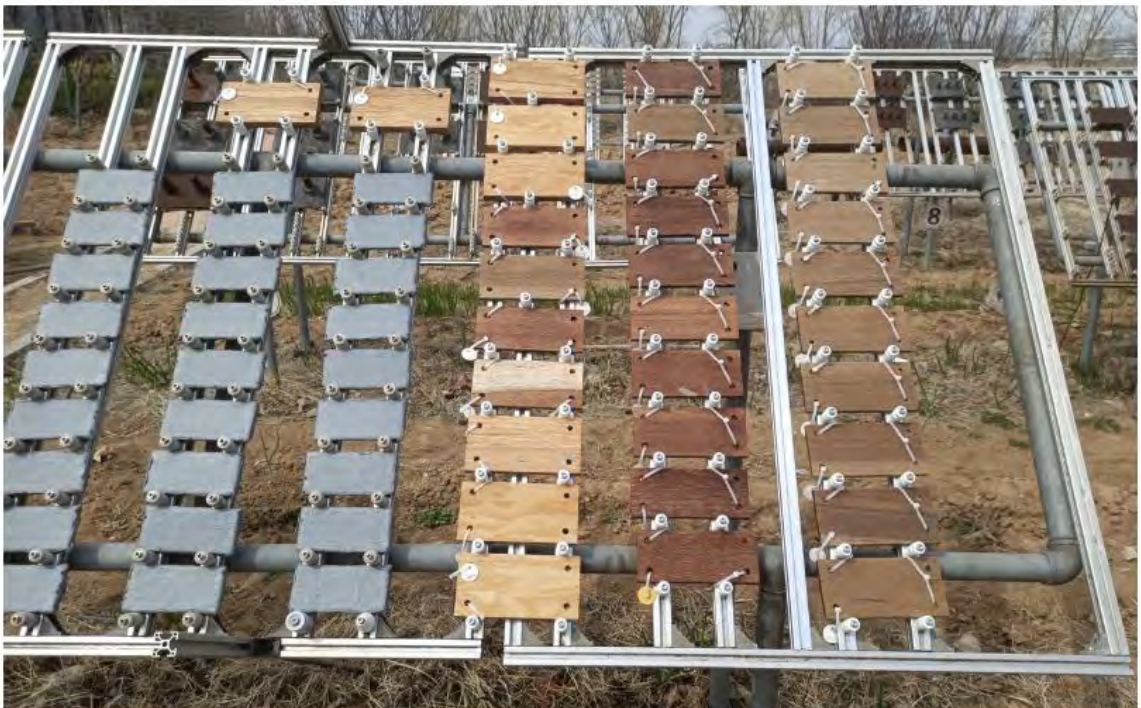
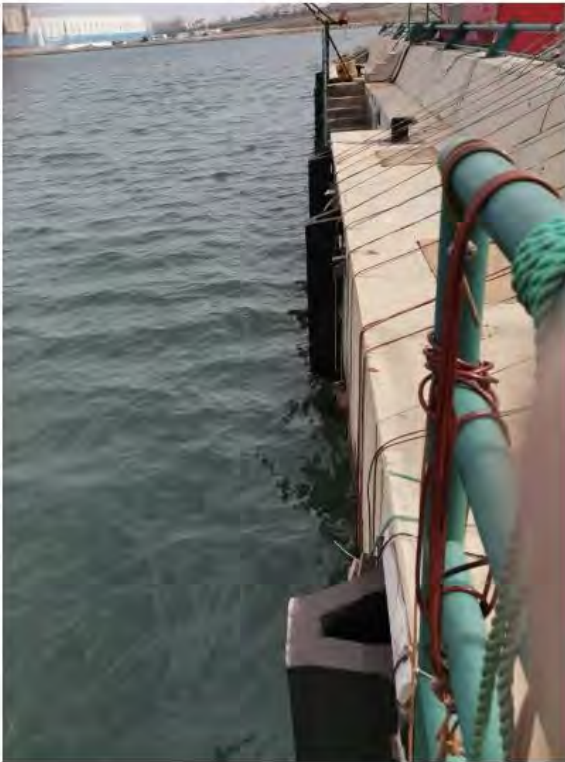
The actual sea hanging stage of wood that needs to be tested in Qingdao has been completed. Figure 6 shows the latest situation of the land atmosphere area and the ocean hanging samples.

Figure 6 Hanging test in Qingdao Oceanic area

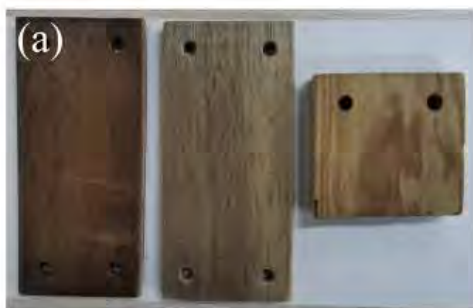
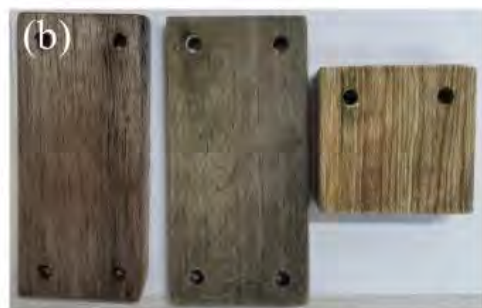
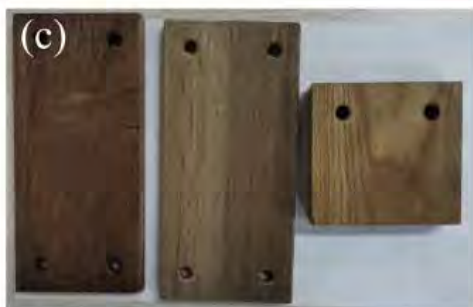
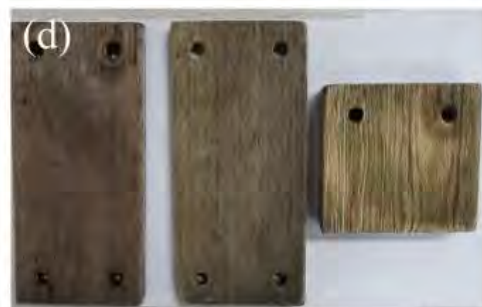
In Figure 7, (a), (b), (c), and (d) samples are samples hung in the marine atmosphere zone for 3 months, in the marine splash zone for 3 months, in the marine atmosphere zone for 6 months, and in the marine splash zone for 6 months. From left to right in each picture are samples of merbau, teak, and Chambroad Timber. From Figure (a), it can be seen that the edges of merbau and teak have slight losses, Chambroad Timber has no obvious losses, and the three materials have no peeling, blistering, or cracking. There is no obvious change in the surface color. From Figure (b), it can be seen that the color of merbau in the splash zone has obviously faded, and there is slight corrosion and slag around it, with obvious splint and more obvious roughness of the texture. There is no obvious change in the surface color of teak, with slight loss on the edge and slight spots. There is no obvious loss on the surface of Chambroad Timber, and the surface is slightly corroded, resulting in obvious roughness of its texture. From Figures (c) and (d), it can be seen that after hanging for 6 months, the surface changes of the three woods are similar to those in the first 3 months.

Figure 7 Surface changing after hanging test of 3months and 6 months at a sea in Qingdao

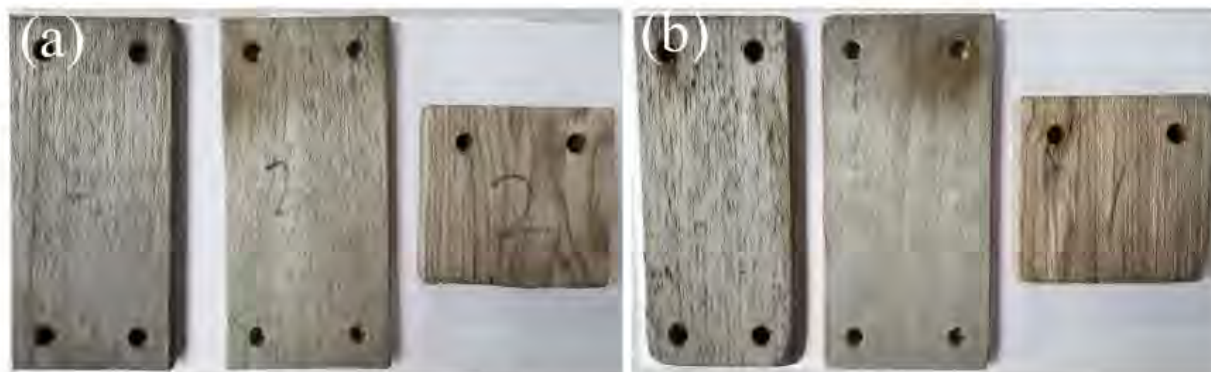
In Figure 8, (a) and (b) samples are divided into samples that were hung in the marine atmosphere zone for 9 months and samples that were hung in the ocean splash zone for 9 months. From left to right in each figure are samples of merbau, teak, and Chambroad Timber. From Figure (a), it can be seen that the edges of merbau and teak have slight losses, and Chambroad Timber has no obvious losses. The surface colors of the three materials have obviously faded, with merbau being the most serious, followed by teak, and Chambroad Timber being the lightest. The surfaces of the three materials have corrosion, resulting in coarsening of the grain, but there is no peeling, blistering, or cracking. From Figure (b), it can be seen that the color of the merbau in the splash zone has obviously faded, and there is slight corrosion and slag around it, with obvious splinters and obviously rough grain. The surface color of teak has faded, there is slight loss on the edges, and there are small cracks at the punching point, which tend to expand. The surface color of Chambroad Timber has faded, and the surface has slight corrosion, resulting in obvious rough grain.

Figure 8 Surface changing after hanging test of 9 months at a sea in Qingdao

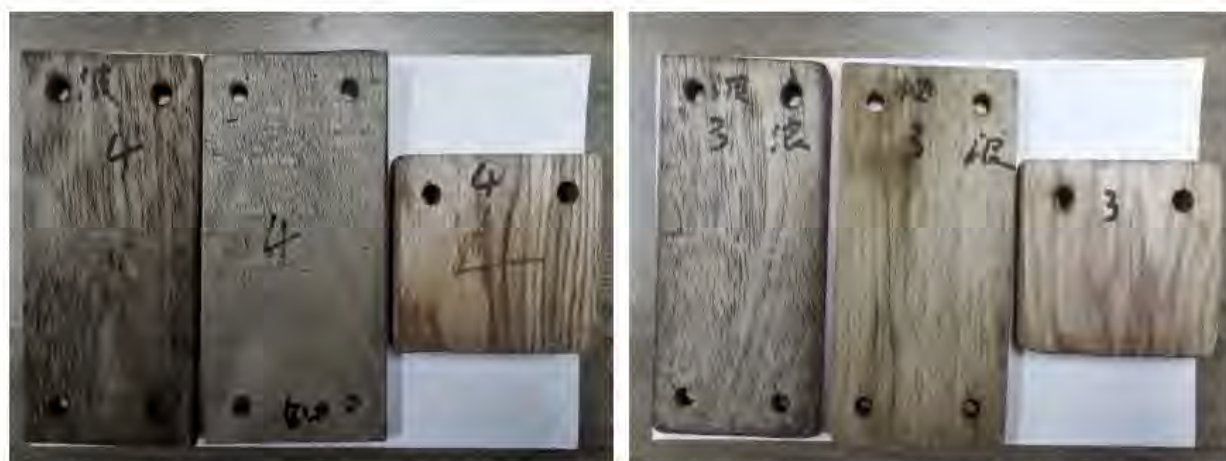
In Figure 9, the left and right pictures are samples of samples hung in the marine atmosphere zone for 12 months and samples hung in the marine splash zone for 12 months. From left to right in each picture are samples of merbau, teak, and Chambroad Timber. From the left picture, it can be seen that the merbau in the atmospheric zone has slight corrosion and slag, with obvious splinters and fine cracks, and the texture is obviously rough. The surface color of teak has faded, the edges have slight losses, and the texture is obvious. The surface color of Chambroad Timber has faded, and the surface has slight corrosion, resulting in obvious roughness of its texture. Careful observation reveals the appearance of fine cracks. The surfaces of all three materials have corrosion, but there is no peeling or blistering. From the right picture, it can be seen that the edges of merbau, teak, and Chambroad Timber have slight losses, and the surface colors of the three materials have faded significantly. There is no peeling or blistering on the surfaces of the three materials.

Figure 9 Surface changing after hanging test of 12 months at a sea in Qingdao

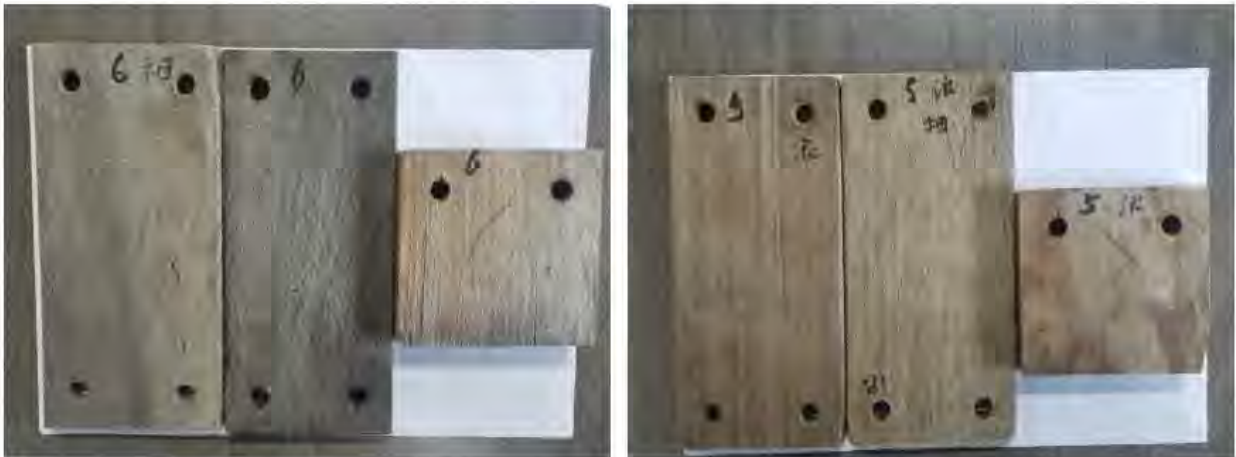
In Figure 10, the left and right pictures are samples of samples hung in the marine atmosphere zone for 15 months and samples hung in the marine splash zone for 15 months. The left picture shows teak, merbau, and Chambroad Timber samples from left to right, and the right picture shows merbau, teak, and Chambroad Timber samples from left to right. From the left picture, it can be seen that the merbau in the atmospheric zone has slight corrosion and slag, with obvious splinters and small cracks, and the texture is obviously rough. The surface color of teak has faded, the edges have slight loss, the texture is obvious, and some holes appear on the surface. The surface color of Chambroad Timber has faded, and the surface has slight corrosion, resulting in obvious roughness of its texture. Careful observation reveals that fine cracks appear in the lower right part. The surfaces of the three materials have a

rough texture and the surface texture is lost, but there is no peeling or blistering. It can be seen from the right picture that the edges of the merbau, teak, and Chambroad Timber samples in the marine splash zone have slight loss, and the surface color of the three materials has faded significantly. There are no cracks, peeling, or blistering on the surfaces of the three materials.

Figure 10 Surface changing after hanging test of 15 months at a sea in Qingdao

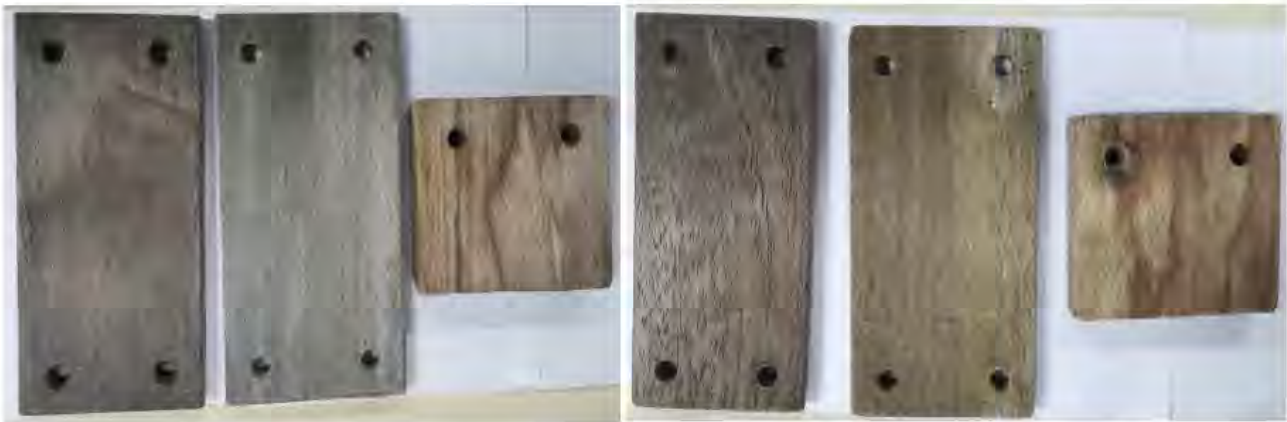
In Figure 11, the left and right pictures are samples of samples hung in the marine atmosphere zone for 21 months and samples hung in the marine splash zone for 21 months. The left picture shows merbau, teak, and Chambroad Timber samples from left to right, and the right picture shows merbau, teak, and Chambroad Timber samples from left to right. It can be seen from the left picture that the merbau in the atmospheric zone has slight corrosion and slag, obvious splinters, obvious large cracks on the side, and small cracks on the front mainly extend from the bottom to the middle, with obvious rough grain. The color of the teak surface fades, there is slight loss on the edge, the grain is obvious, and the cracks are not obvious. The color of the Chambroad Timber surface fades, and the slight corrosion on the surface causes its grain to be obviously rough. The texture of the three materials is rough and the surface texture is lost. It can be seen from the right picture that the merbau, teak, and Chambroad Timber samples in the marine splash zone are better than those in the atmospheric zone, with obvious thickening of the texture, slight loss of the edge, and obvious lightening of the surface color of the three materials. There are no cracks, peeling, or blistering on the surface of the three materials.

Figure 11 Surface changing after hanging test of 21 months at a sea in Qingdao

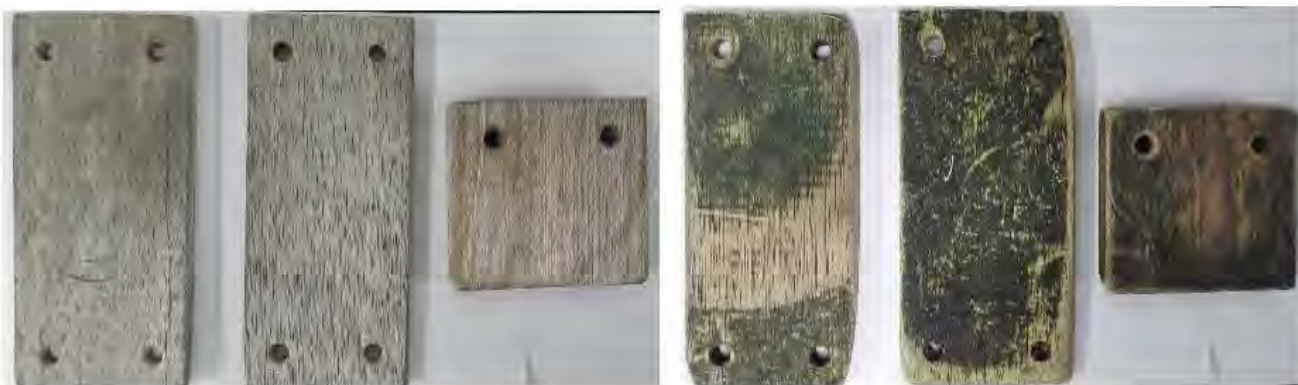
In Figure 12, the left and right pictures are samples of samples hung in the marine atmosphere zone for 27 months and samples hung in the marine splash zone for 27 months. The left picture shows Teak, Merbau, Chambroad Timber samples from left to right, Teak, Merbau, and Chambroad Timber samples. From the left picture, it can be seen that the Teak in the marine atmosphere zone has a rough texture, slight corrosion and slag, burrs, and a large crack running through the right side. There are fine cracks extending from the bottom to the middle on the upper and lower edges. The Merbau surface has a rough texture and a lighter color. There are fine cracks on the lower edge extending from the bottom to the middle and fine cracks inside. The Chambroad Timber surface color fades, and the surface is slightly corroded, resulting in a rough texture. There are fine cracks at some positions on the edge. The texture of the three materials is rough and the surface texture is lost. From the right picture, it can be seen that the Teak, Merbau, and Chambroad Timber samples are better than those in the atmospheric zone, with a significantly coarser texture and sediments after seawater scouring. There are fine cracks inside Teak and Merbau, but compared with the marine atmosphere zone, the cracks are smaller and fewer. There are no obvious cracks inside Chambroad Timber.

Figure 12 Surface changing after hanging test of 27 months at a sea in Qingdao

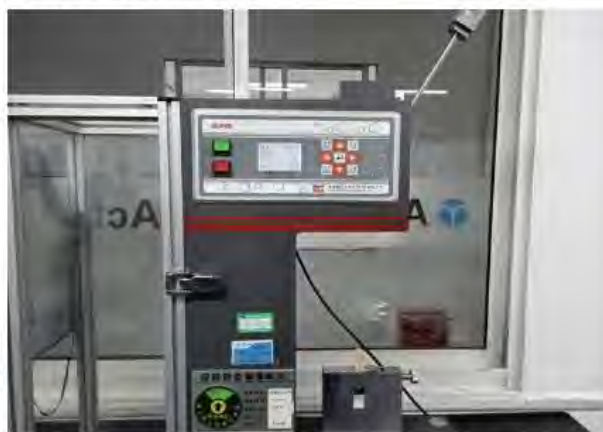
As shown in the figure below, this method is to place the sample at the specified position of the simply supported beam impact machine, and then use the pendulum to fall freely to apply an impact load to the sample to break the sample. The energy absorbed by the unit cross-sectional area of the sample during the sample destruction or process, that is, the impact strength, is recorded to measure the impact toughness of the material.

First, accurately measure the width and thickness of the spline, check whether the testing machine has the specified impact speed and the correct energy range, and the energy absorbed by the broken sample is within the range of 10% to 80% of the pendulum capacity. Perform a blank test and record the measured friction loss. Lift and lock the pendulum, place the sample in a vise, and clamp the sample according to the mechanical requirements. The notch should be on the side of the pendulum impact blade. Release the pendulum, break the spline, and read and record the impact energy absorbed by the sample.

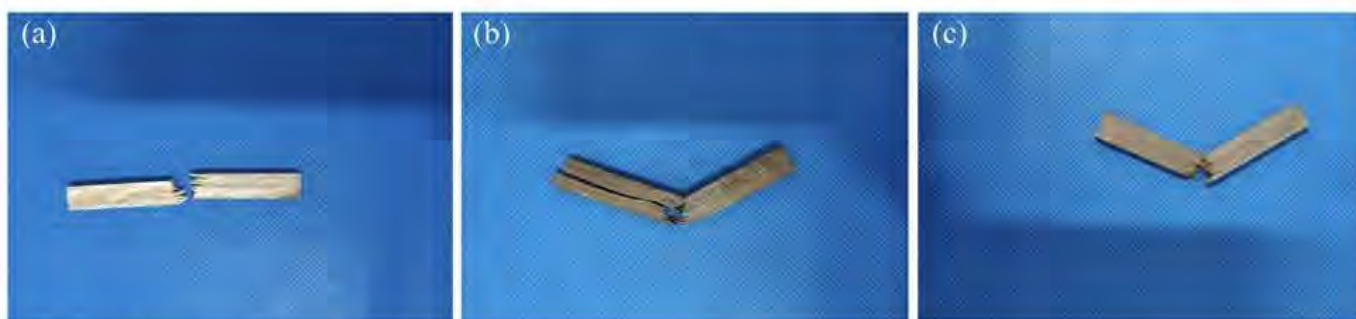
As shown in the figure below, (a), (b), and (c) are the splines after Chambroad Timber, merbau, and teak impact, respectively. This experimental impact adopts the cantilever beam impact test method, and the pendulum energy is 4J.

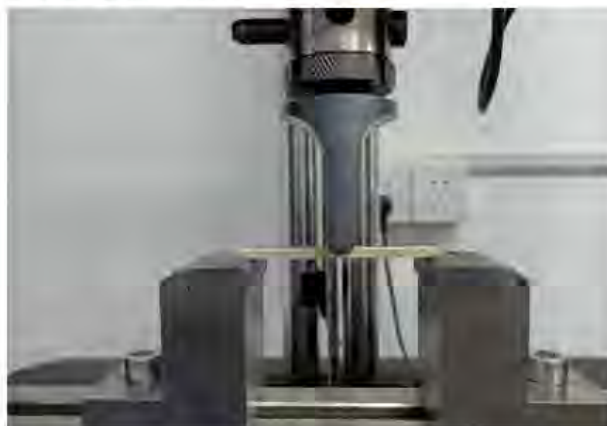
Measure the width and thickness of the specimen as shown in the figure below. The width is measured at the center of the long side of the specimen; the thickness is measured at the intersection of the diagonal lines of the specimen. Adjust the span of the two supports to at least 20 times the basic thickness of the specimen. The specimen is placed flat on the supports, with the long axis of the specimen perpendicular to the support rod and the center point of the specimen below the loading rod. Load at a constant speed throughout the test. Reach the maximum load within  $(60 \pm 30)$ s until the specimen is destroyed. Read the displacement load data from the machine and draw a curve.

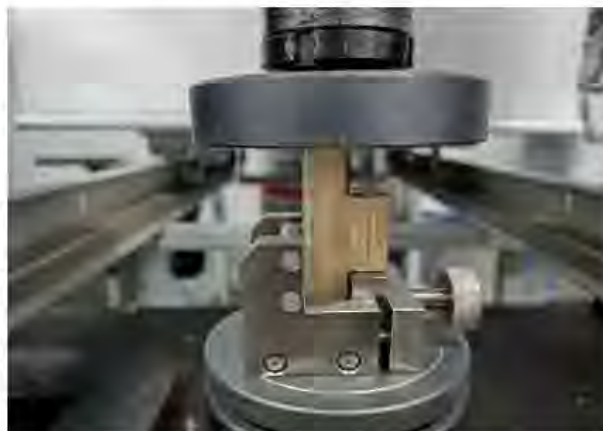
First, measure the width and length of the shear surface of the specimen. As shown in the figure below, place the specimen into the test machine fixture, and do not use the adjustment screw to press the specimen. Place the fixture on the test machine and keep the center of the specimen's force surface consistent with the center of the pressure head. Apply the load evenly so that the specimen is destroyed within  $(60 \pm 30)$  s. After the specimen is destroyed, read the experimental load displacement curve.

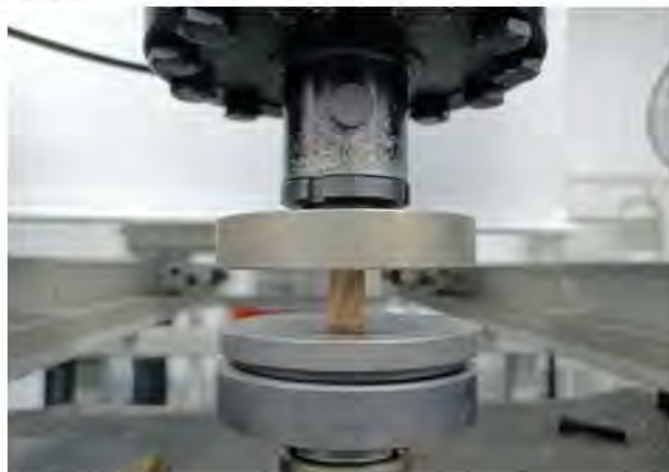
This experiment determines the compressive performance by determining the ratio of the maximum longitudinal compression load to the cross-sectional area of the specimen. First, measure the width and length of the specimen, place the specimen on the support, apply the load evenly, and completely destroy the specimen within (60±30) seconds. Read the machine parameters, as shown in the figure below.
